NoordzeeWind

Operations Report 2009

Document No: Date: Internet: OWEZ_R_000_20101112 November 2010 www.noordzeewind.nl

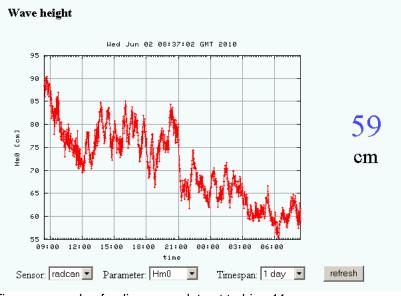
Figure: example of online wave data at turbine 11

In order to provide more data on actual sea state and wave heights the wave measurement system (Radac -wave radar) was installed at turbine 11 and is wave data is now available on line for vessel control purposes.
